Stormwater Drainage Improvements Completed

June 10, 2020

In early March, the Board of Directors of the Terrace Townhouses of Beverly Hills Association (TTBH) approved a major **Stormwater Drainage Improvement Project** across the fronts of units **1768-1776 Dogwood Drive**. The proposed work to replace and upgrade the stormwater infrastructure from the downspouts along the main sidewalk in that common area would mitigate recurring flooding conditions. This particular area had continued to be inundated with several inches of standing water in some locations during heavy rainstorms.

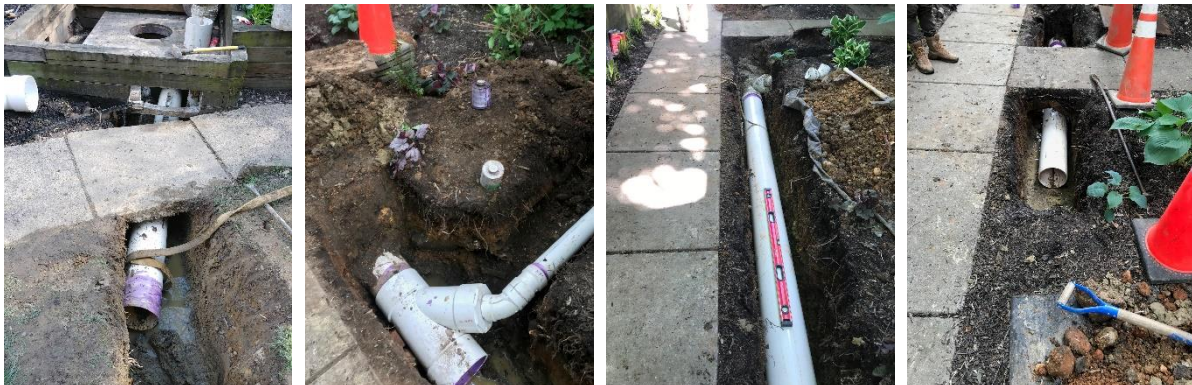
The project started by digging up a trench to the side near 1776 Dogwood Drive to put the trunk line and downspout drains. All other units affected were separately informed of the upcoming work and impacts. Additional pictures below showing the installation work of the new PVC line as per the scope of work.

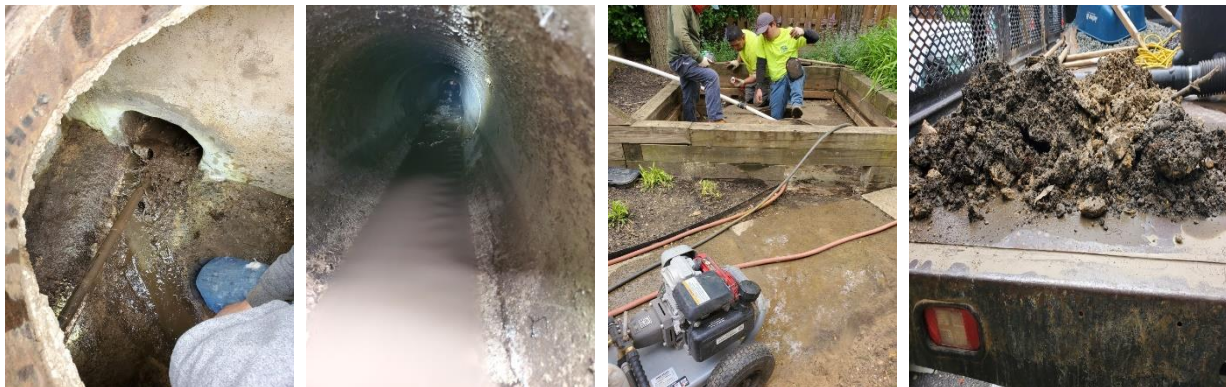
While the project was underway, a significant clog was found within the main stormwater drain that connects to the City of Alexandria infrastructure – which was contributing to flooding conditions in that area of the community. Consequently, a second competitive process was initiated and an additional vendor was retained to clear out debris and mud from the pipe.

The contractor was able to flush the clogged pipe as shown in the pictures above. Everything was completed in a timely fashion. Work on the stormwater drainage continued with no further complications.

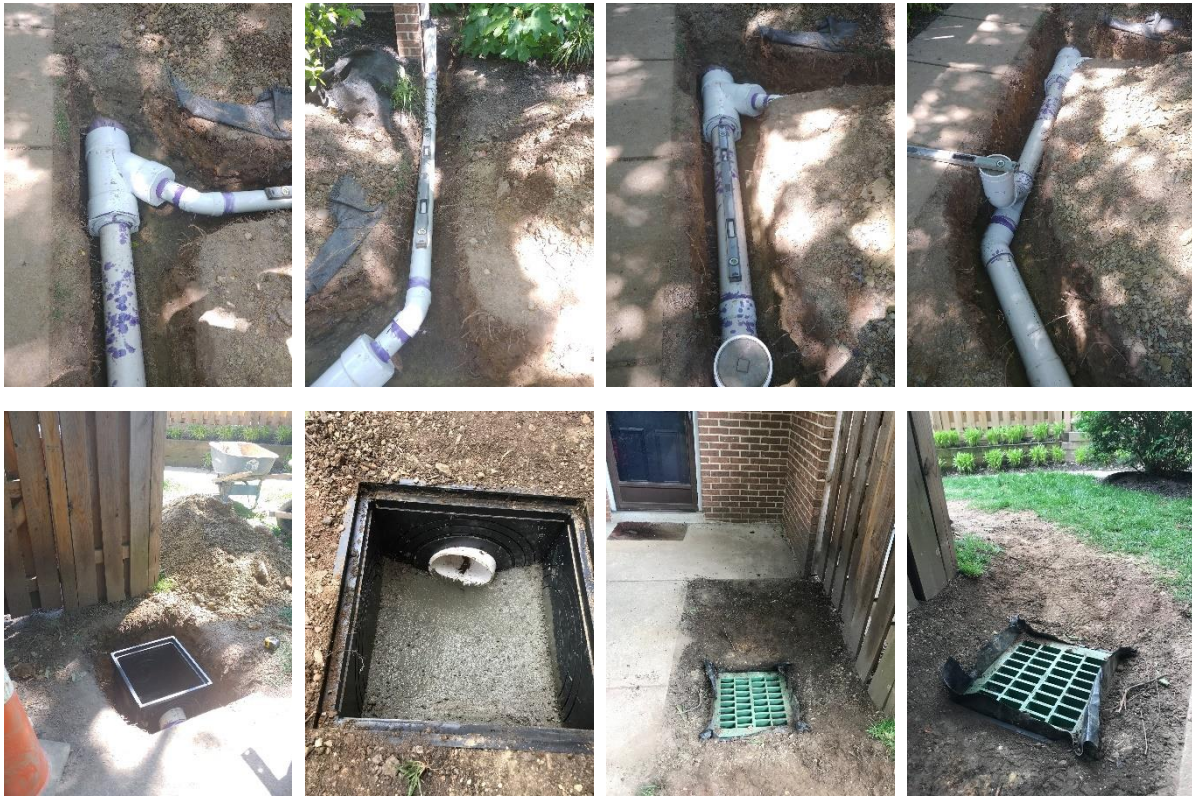
Additional photos below show the final stages of the stormwater drainage project's completion.

The entire project was completed Tuesday, May 19, and a final walkthrough was completed on the same day. Work was deemed satisfactory with no additional pending punch list items.
